Application report - 15

REWITEC® gas engine treatment

Project Task: Application with REWITEC® PowerShot® to reduce wear and prolong lifetime

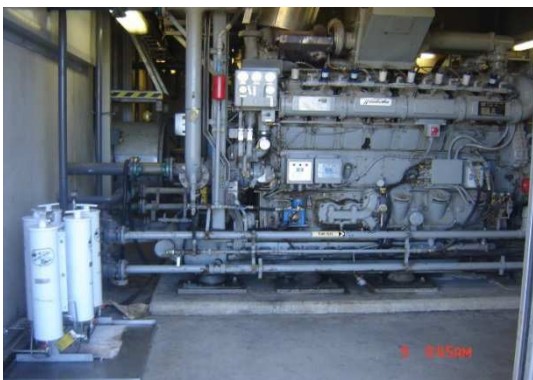
Fig. 1: 1995 Modell F18GL Waukesha K-005

The engine selected for this trial was a Model F18GL Waukesha gas engine K-005 similar make to that shown in Fig 1.

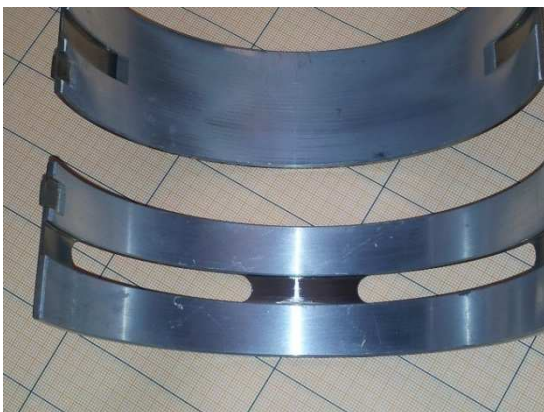
At this point samples of the K-005 Main and Big End bearings were obtained as shown in Fig 2 & 3.

These show minimal wear signs and were within tolerance of new bearings.

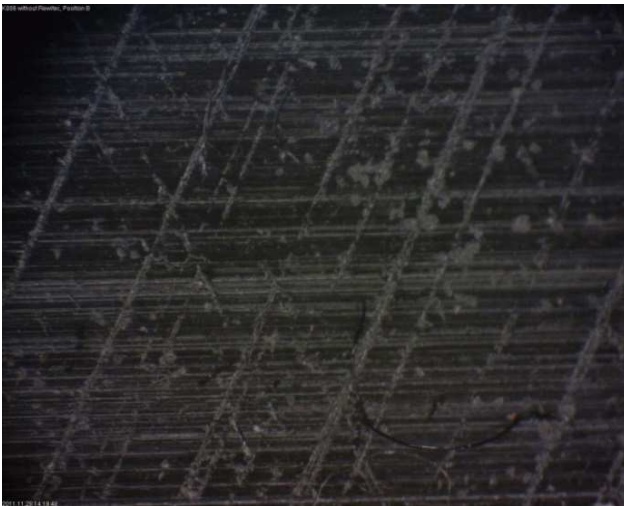
- The Metal from the Cylinder liner has surfaces wear.
- There is Pitting present.
- The cylinder will loose some compression.
- The diagonal marks are the original honing impressions.
- The horizontal are caused by piston movement.

In addition to these bearings a cylinder liner was also obtained from K-005 along with one other cylinder liner from an adjacent plant engine K-006 that had not been treated with the REWITEC®.

This was done as a control for comparison of the untreated and treated surface conditions, as both were working at the time of application, and are shown in Fig 4 & 5.

REWITEC® Replica sampling was done on each of the cylinder surfaces and identified as K-005 and K-006. Each cylinder was given a special coating on its internal surface and a special impression was taken for the Lab examination.

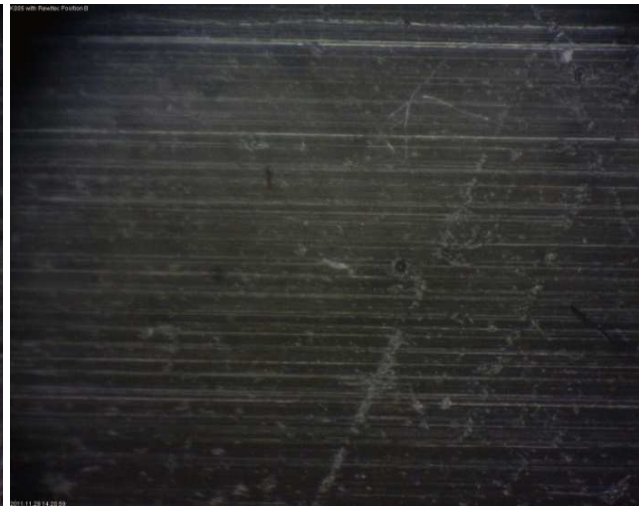
Fig 5

- The Cylinder that was treated looks better.
- The whole Surface is smoother.
- Pitting is barely present due to the REWITEC® resurfacing.
- The Piston can rest better at the cylinder wall.
- Compression will get better.
